Faculty of
Science and
Technology
Tokushima University

Seismic Design of Wooden Buildings

Professor Hiroki Ogawa

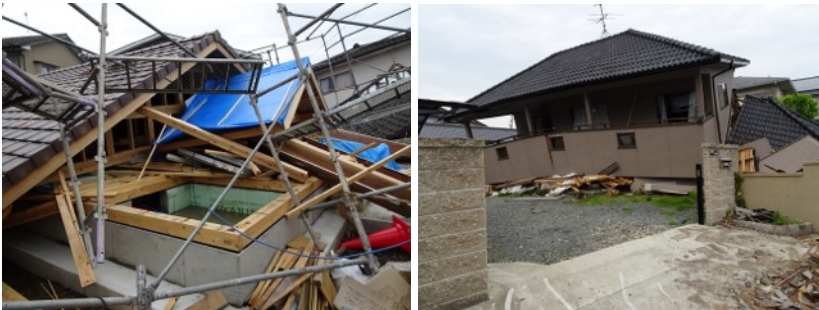
Photo. Damage of the dwellings caused by the Kumamoto earthquake in Mashiki Town

By the Kumamoto earthquake generated in April, 2016, damage occurred in much wooden building by strong shaking with a seismic intensity of 7. Our group performed field works about the damage of the wooden buildings just after an earthquake. As a result, we confirmed heavy damage such as the collapse to buildings with the problem in a foundation and proof stress elements.
